Finley Home Services
8417 WASHINGTON BLVD
SUITE 180
9167412847

Property Inspection Report

1234 Example Drive
Sacramento, California 95838

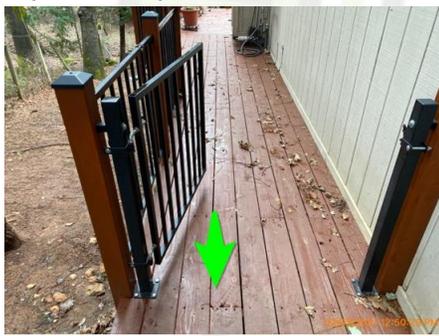
BACK PATIO / PORCH GROUNDS SLAB / SURFACE

RR s-22: Dry rot / deterioration noted to deck surface. Recommend repair. Also refer to pest inspection report for repair recommendations.

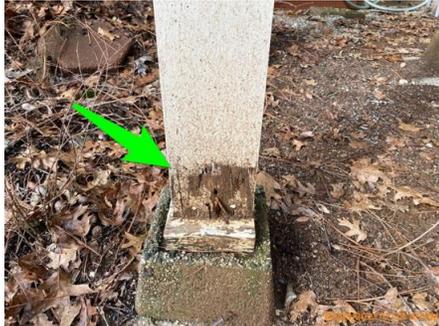
Post Base

RR s-24: Dry rot / deterioration noted at base of posts, stringer and stringer pad framing. Recommend repair. Also refer to pest inspection report for repair recommendations.

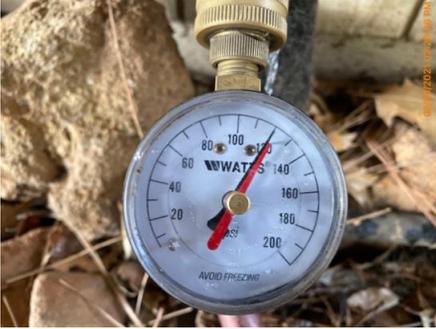
WATER PRESSURE GROUNDS MAIN WATER LINE

RR s-34: Anything over 100 psi is considered excessive. Water pressure this high can cause damage to fill valves in toilets, dishwasher, and clothes washer. If the supplying utility company cannot adjust the pressure for you, then recommend having a licensed plumber install a water pressure regulator to regulate the pressure to an acceptable 40 to 80 psi range.

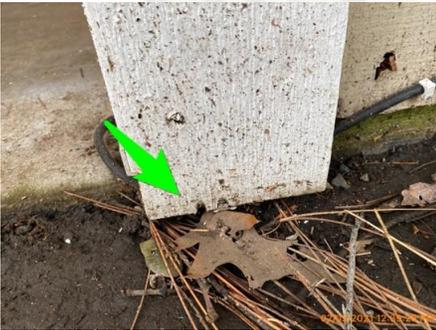
EXTERIOR WALLS EXTERIOR - FOUNDATION FLASHING & TRIM

RR s-47: Exterior trim components showed general deterioration at the time of the inspection and needed repair or replacement on various sides. Also refer to pest inspection report for repair recommendations.

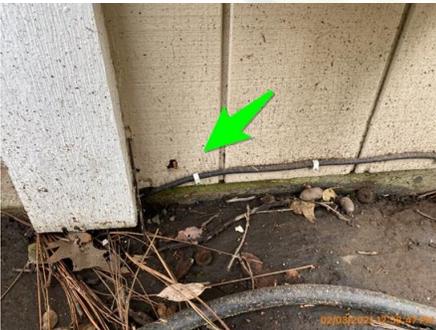
EXTERIOR WALLS EXTERIOR - FOUNDATION MATERIALS & CONDITION

RR s-48: Some deterioration / rot observed to siding on various sides of the house. Recommend repairs to damaged areas as needed by a qualified siding contractor. Also refer to pest inspection report for repair recommendations.

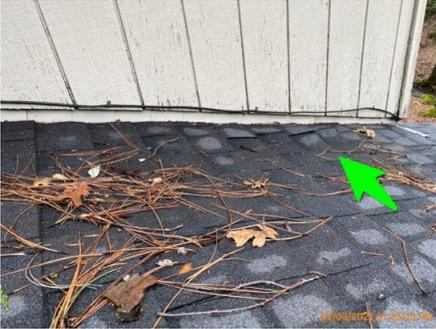
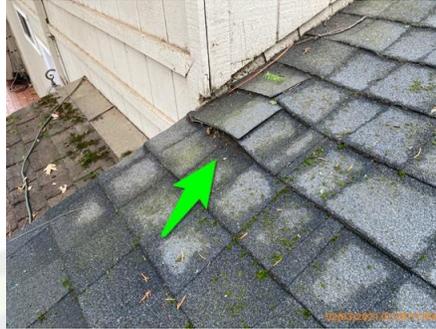
ROOF SYSTEM FLASHINGS

RR s-60: The flashing at the intersection of the roofing material and a wall is raised / lifted, allowing a potential point of entry for water. Recommend repair and/or replace as needed by a qualified roofing contractor.

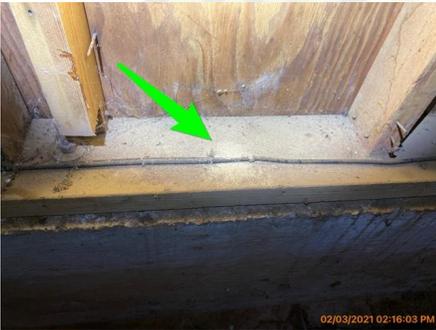
CRAWLSPACE - BASEMENT WALLS

RR s-84: Evidence of insect activity noted. The home inspector is unable to verify whether this is current or past activity. Recommend pest inspection and treatment by Finley Home Services Pest Division or another licensed pest company. Also refer to pest inspection report for repair recommendations if available.

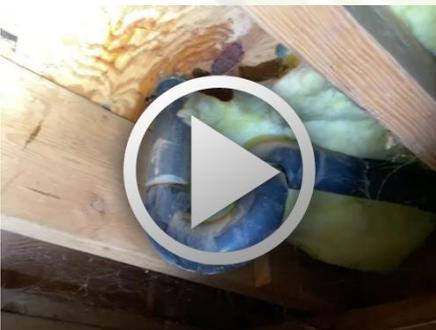
CRAWLSPACE - BASEMENT WASTE LINES

RR s-95: Leaking noted under downstairs bath shower area. Recommend repair and/or replace as needed by a licensed plumber.

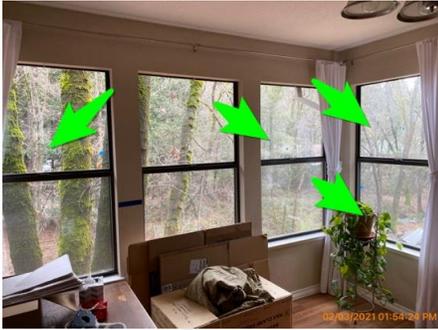
INTERIOR WINDOWS INTERIOR ROOMS INTERIOR WINDOWS

RR s-201: Hardwater staining / scale noted to the exterior side of some of the windows, likely due to overspray of sprinklers or deferred maintenance over time. Make repairs as needed., There is moisture / condensation between window panes in the various locations including the dining room, living room and both upstairs front bedroom. This is a commonly seen defect in older double paned windows and generally considered a cosmetic repair. However, when there are multiple windows with condensation, it is more costly to repair. Have a qualified window contractor / glazer make further evaluation and repairs as needed. Blue tape has been placed on each window that the inspector was able to verify, visibly and that there is cosmetic damage.

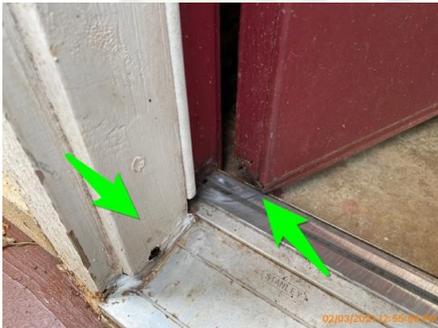
RR s-233: Deterioration noted to door and jamb. A qualified trim carpenter should be called to make repairs as needed. Also refer to pest inspection report for repair recommendations.

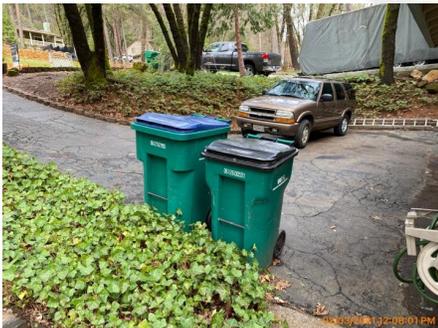
PAVING CONDITIONS GROUNDS DRIVEWAY

MM s-10: The driveway slopes toward the building. Recommend further evaluation during the rainy season, and repair if needed. Inquire with the seller regarding any ponding or collection of water and monitor for appropriate drainage.

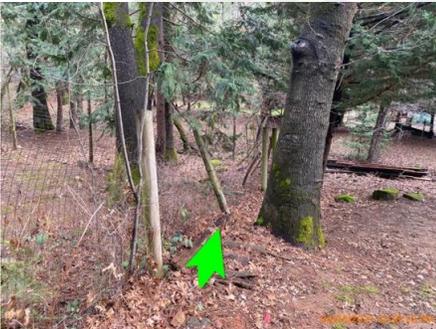
MM s-38: Loose/unstable/leaning posts observed on various sides of the property and likely due to the close proximity of the tree near the fence. Have a qualified fencing contractor make repairs as needed. You may wish to consult an arborist for further evaluation and repair recommendations.

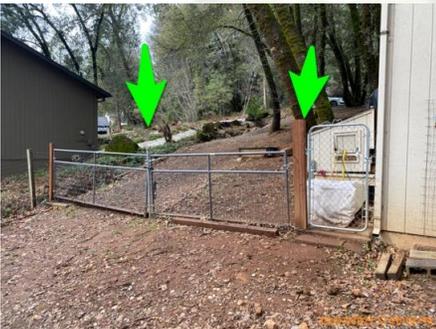
MM s-39: Gate on the right side of the house locked at the time of inspection. Unable to determine functionality of gate.

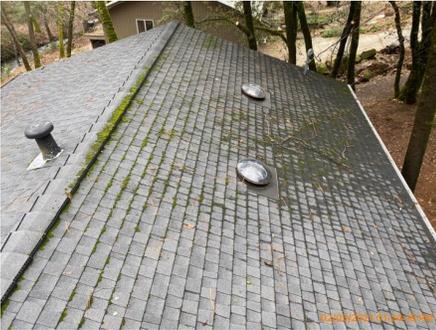
MM s-58: Type: Composition Shingles. General condition appears serviceable with normal signs of aging. The average life expectancy in the local area for a composite shingle roof is 25-30 years. Regular maintenance recommended: This usually consists of repair/replacement of damaged/missing shingles. This maintenance should help ensure the integrity of the roof and should be performed by a licensed roofing contractor periodically. Ridge venting is present to allow for more air flow to the attic and is considered an upgrade. Lichen/moss growth observed. Organic growth can be lightened by the gentle application of bleach or more eco friendly option with a brush or broom then scraped and rinsed off. It is common for roofs to have growth and especially north facing.

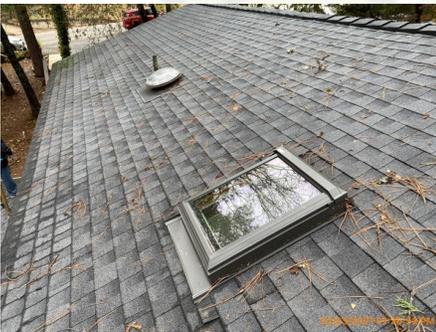
ROOF SYSTEM SKYLIGHT

MM s-63: The skylight can be opened to allow hot air to exit the structure. Skylight was not opened. Unable to locate opening tool.

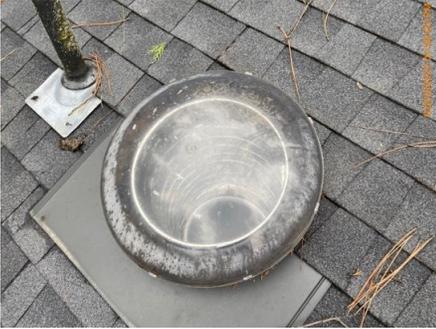
Condensation

MM s-65: There is moisture condensation or evidence of previous condensation between the skylight window panes. The window thermal seal appears to be broken. Recommend a licensed window contractor replace the window glass.

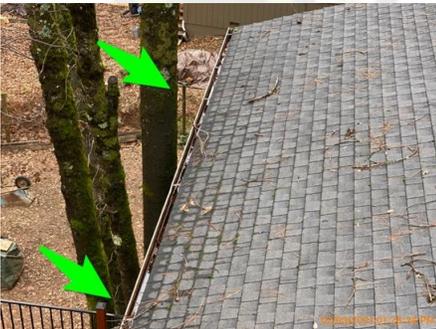
MM s-68: Standing water noted in gutters on various sides of the house due to debris and/or clogged downspouts. Cleaning and sealing recommended, periodically.

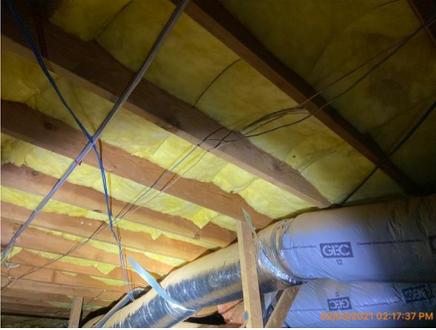
MM s-88: Underfloor insulation restricts full viewing of subfloor and framing structure.

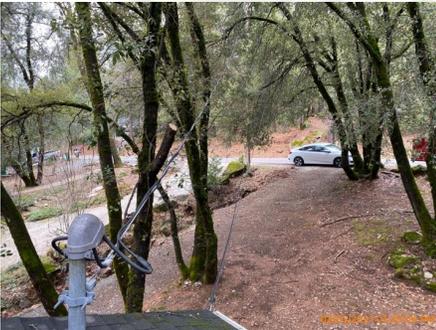
MM s-99: Overhead conductors are too close to nearby tree branches, which may damage the wires. Have the power company trim as needed and possibly at no cost to the homeowner.

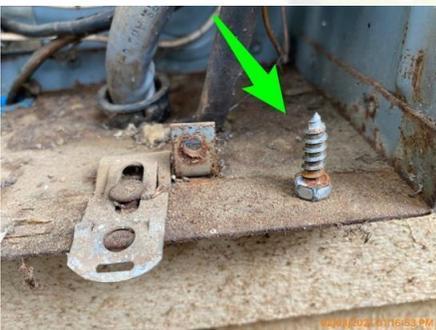
MM s-105: Improper screw noted. Screw has a sharp point that could penetrate the insulation around wiring and come in contact with a live wire. No wiring noted at the location of this screw. Recommend replacement with a screw that lacks a sharp point and is designed for electrical use.

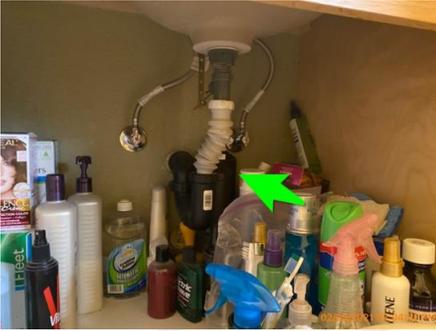
MM s-146: Flex piping is installed at the sink drain line. While it is a popular product at Lowe's and Home Depot and it is considered poor practice to install flexible drain piping because it tends to clog easier and will usually drain slower. Alo

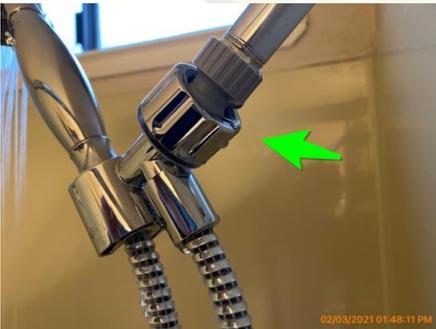
MM s-158: Dripping observed at the showerhead. Left uncorrected this could cause moisture damage behind the shower / tub walls. Recommend repair and/or replace as needed.

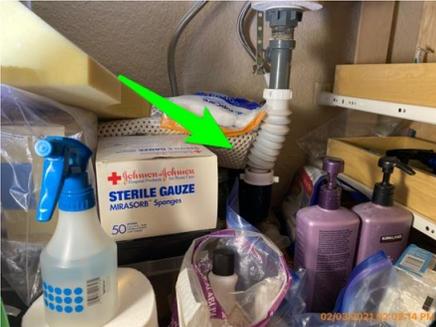
MM s-166: Flex piping is installed at the sink drain line. While it is a popular product at Lowe's and Home Depot and it is considered poor practice to install flexible drain piping because it tends to clog easier and will usually drain slower. Alo

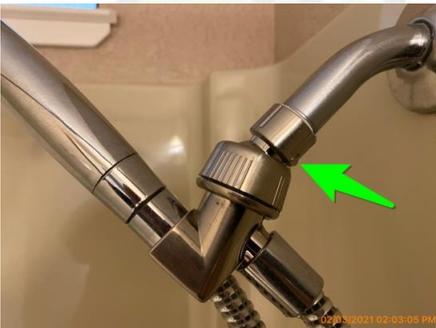
MM s-169: Dripping observed at the showerhead. Left uncorrected this could cause moisture damage behind the shower / tub walls. Recommend repair and/or replace as needed.

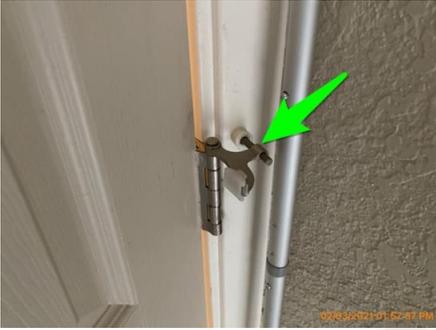
MM s-184: Door stoppers are not preventing the door from contacting the wall in various locations and are in need of adjustment or replacing.

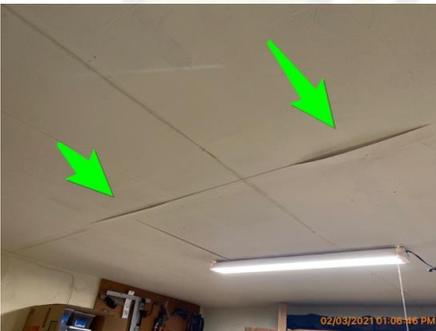
MM s-223: Some of the drywall tape that seals the seams and completes the firewall has come loose and needs to be replaced.

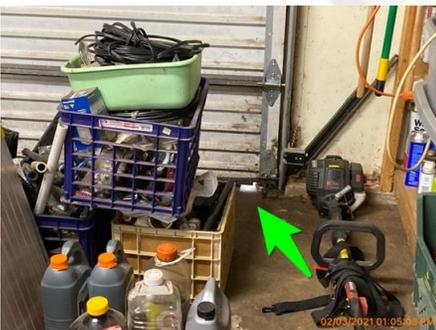
MM s-230: There is a small gap at the left side and right side of the door when it is closed. This is a potential point of entry for water and pests / animals. Recommend adjustment of weather stripping as needed.

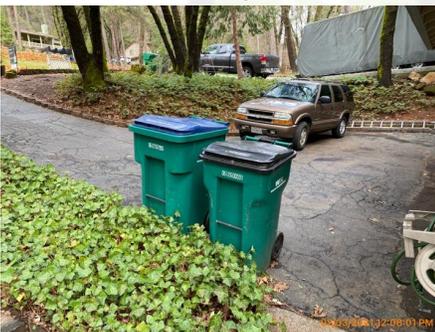
MM 10: The driveway slopes toward the building. Recommend further evaluation during the rainy season, and repair if needed. Inquire with the seller regarding any ponding or collection of water and monitor for appropriate drainage.

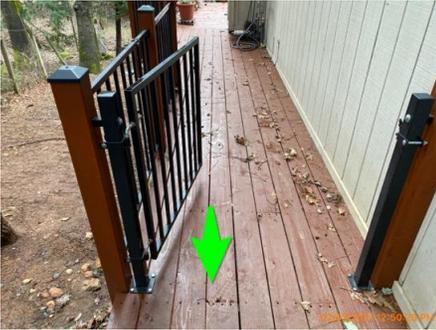
RR 22: Dry rot / deterioration noted to deck surface. Recommend repair. Also refer to pest inspection report for repair recommendations.

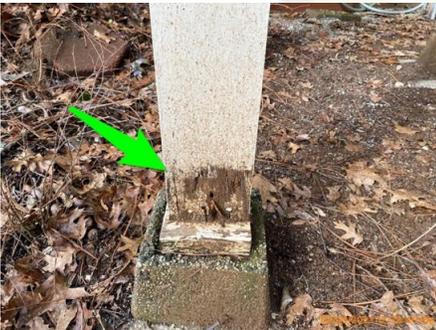
RR 24: Dry rot / deterioration noted at base of posts, stringer and stringer pad framing. Recommend repair. Also refer to pest inspection report for repair recommendations.

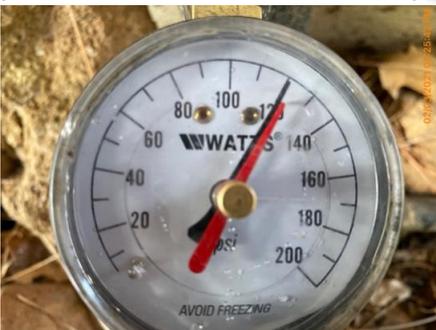
33: The static water pressure measured 120 pounds per square inch (psi). Water pressure from 40 to 80 psi is considered within an acceptable range.

RR 34: Anything over 100 psi is considered excessive. Water pressure this high can cause damage to fill valves in toilets, dishwasher, and clothes washer. If the supplying utility company cannot adjust the pressure for you, then recommend having a licensed plumber install a water pressure regulator to regulate the pressure to an acceptable 40 to 80 psi range.

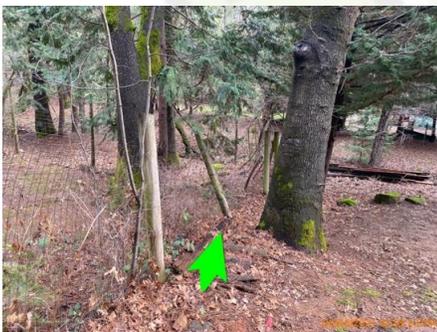
MM 38: Loose/unstable/leaning posts observed on various sides of the property and likely due to the close proximity of the tree near the fence. Have a qualified fencing contractor make repairs as needed. You may wish to consult an arborist for further evaluation and repair recommendations.

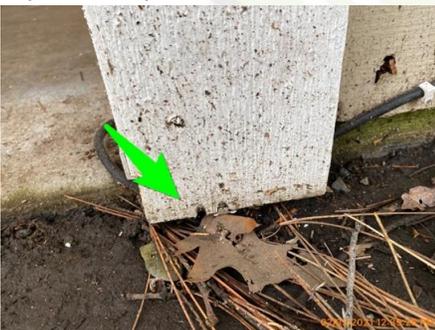
RR 47: Exterior trim components showed general deterioration at the time of the inspection and needed repair or replacement on various sides. Also refer to pest inspection report for repair recommendations.

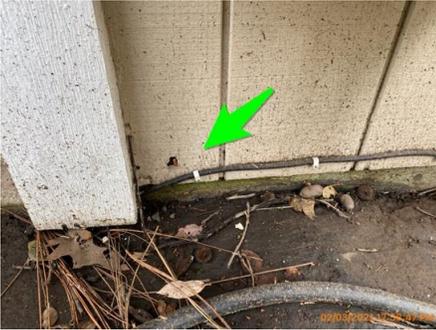
RR 48: Some deterioration / rot observed to siding on various sides of the house. Recommend repairs to damaged areas as needed by a qualified siding contractor. Also refer to pest inspection report for repair recommendations.

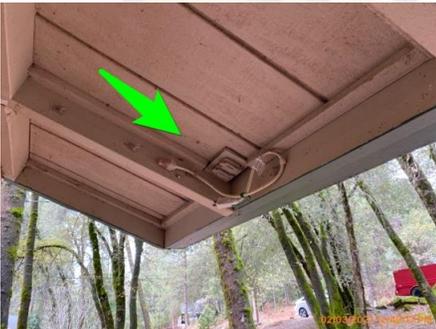
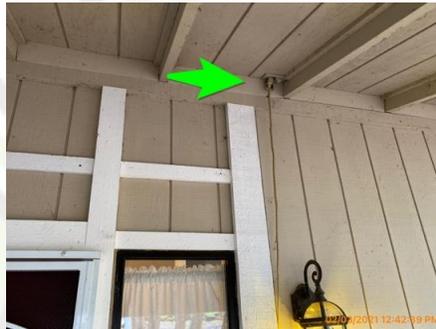
52: Inoperative electrical outlet noted on the front eaves of the house. Recommend repair and/or replace as needed by a licensed electrician.

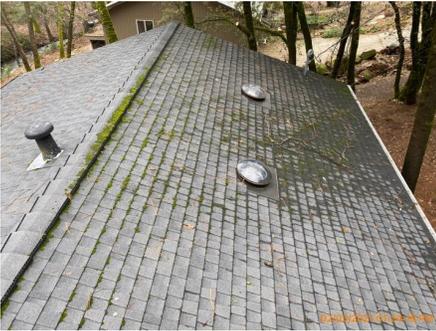
MM 58: Type: Composition Shingles. General condition appears serviceable with normal signs of aging. The average life expectancy in the local area for a composite shingle roof is 25-30 years. Regular maintenance recommended: This usually consists of repair/replacement of damaged/missing shingles. This maintenance should help ensure the integrity of the roof and should be performed by a licensed roofing contractor periodically. Ridge venting is present to allow for more air flow to the attic and is considered an upgrade. Lichen/moss growth observed. Organic growth can be lightened by the gentle application of bleach or more eco friendly option with a brush or broom then scraped and rinsed off. It is common for roofs to have growth and especially north facing.

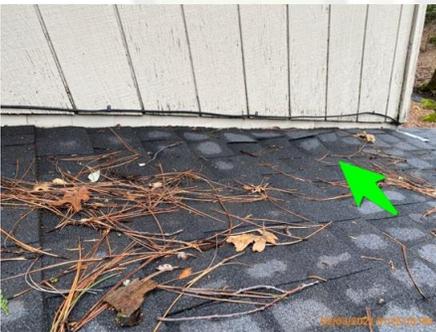
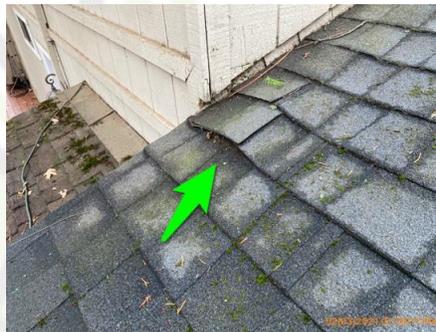
RR 60: The flashing at the intersection of the roofing material and a wall is raised / lifted, allowing a potential point of entry for water. Recommend repair and/or replace as needed by a qualified roofing contractor.

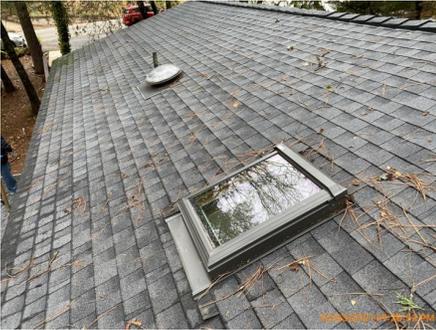
MM 63: The skylight can be opened to allow hot air to exit the structure. Skylight was not opened. Unable to locate opening tool.

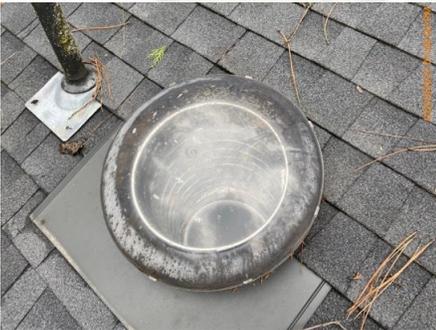
Condensation

MM 65: There is moisture condensation or evidence of previous condensation between the skylight window panes. The window thermal seal appears to be broken. Recommend a licensed window contractor replace the window glass.

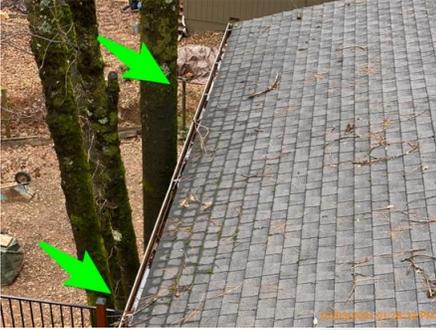
MM 68: Standing water noted in gutters on various sides of the house due to debris and/or clogged downspouts. Cleaning and sealing recommended, periodically.

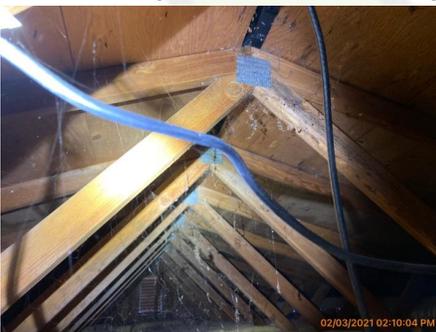
70: There is a truss framing system installed in the attic enclosure to support the roof decking and transmit the roof weight to the load bearing walls. The truss system appears to be sufficient.

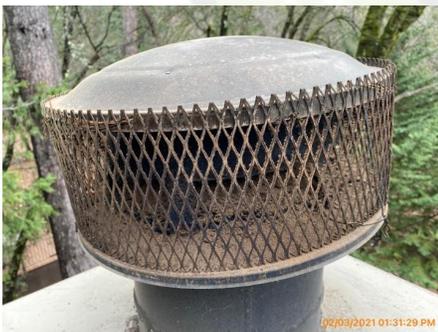
MM 78: The inspector was unable to determine the condition of the flue liner due to limited visibility. Periodic inspection and cleaning recommended by a qualified chimney sweep.

79: Chimney cleaning is recommended to remove creosote deposits and other debris from chimneys and vents. Inspections and cleaning should be performed regularly. Recommend cleaning by qualified chimney specialist prior to use.

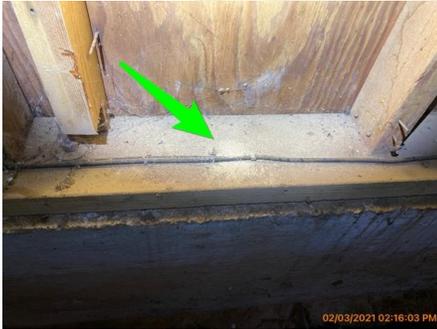
RR 84: Evidence of insect activity noted. The home inspector is unable to verify whether this is current or past activity. Recommend pest inspection and treatment by Finley Home Services Pest Division or another licensed pest company. Also refer to pest inspection report for repair recommendations if available.

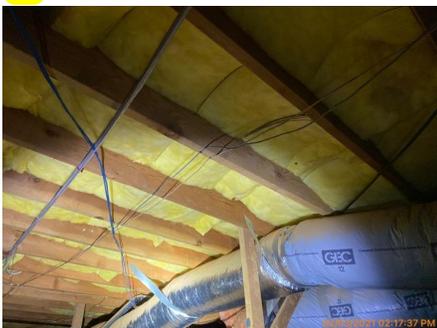
MM 88: Underfloor insulation restricts full viewing of subfloor and framing structure.

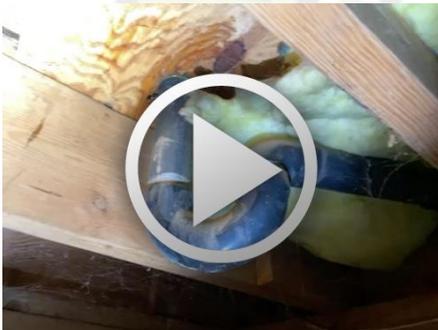
RR 95: Leaking noted under downstairs bath shower area. Recommend repair and/or replace as needed by a licensed plumber.

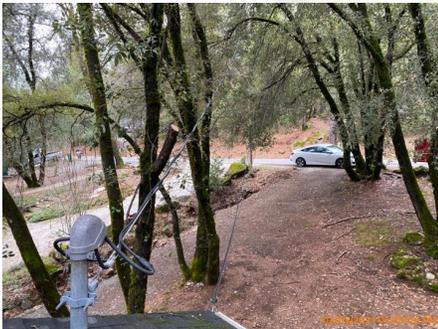
MM 99: Overhead conductors are too close to nearby tree branches, which may damage the wires. Have the power company trim as needed and possibly at no cost to the homeowner.

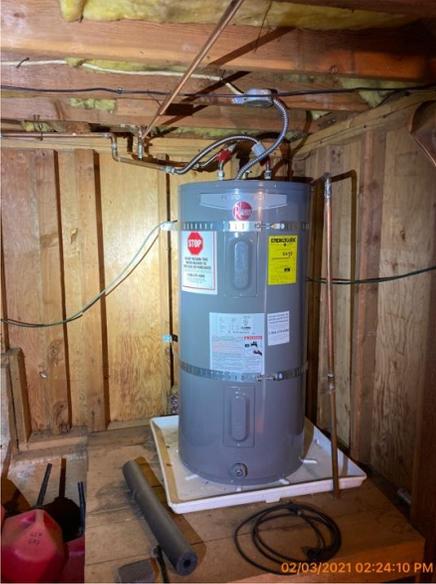
122: Electric powered water heater with no Expansion Tank. Pressure relief valve noted, not tested. A water shutoff valve is installed but not tested. Water heater appears to be properly seismically secured. General condition appears serviceable. Recommend having a plumber maintain this system regularly, as recommended per manufacturer's s maintenance advisory. Overflow pan noted. No piping noted to direct potential leakage from the water heater to the exterior.

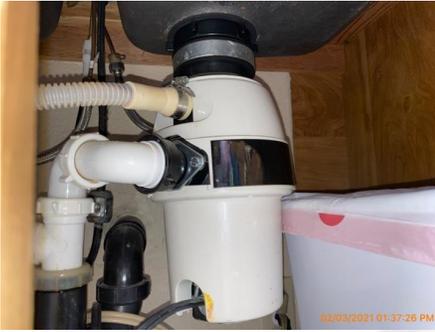
GARBAGE DISPOSAL

132: The garbage disposal operated properly at the time of the inspection. Wiring appears serviceable.

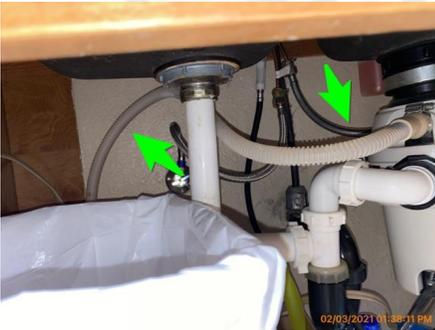
DISHWASHER

133: The dishwasher operated through a full cycle and appeared to be in serviceable condition at the time of the inspection.

134: The dishwasher had a high loop installed in the drain line at the time of the inspection. The high loop helps to prevent drain water from contaminating the dishwasher. and The high loop appeared to be operating properly at the time of the inspection. While this is considered an acceptable configuration we recommend installing an air gap.

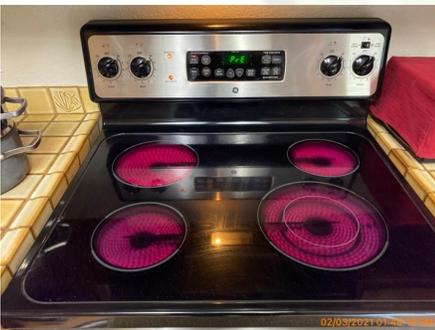
COOKTOP

135: Electric. Cooktop combined with oven. and General condition appears serviceable. Operated all burners/elements at time of inspection.

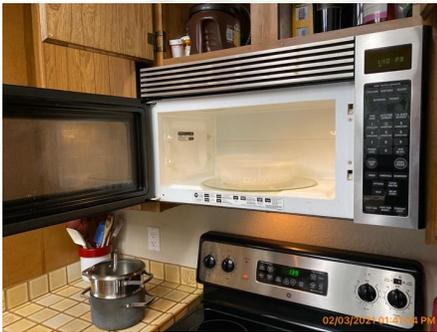
MICROWAVE

139: The microwave operated properly at the time of the inspection.

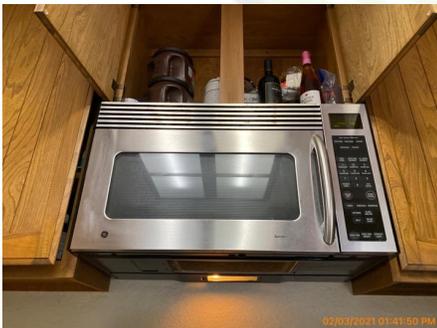
VENTILATION

140: Vent fan was operational at the time of the inspection. Note: Regular service and cleaning is required for the filter to work at optimum efficiency. Recirculation type and not vented to the outside. There is a window nearby to aide in the ventilation of re-circulating air.

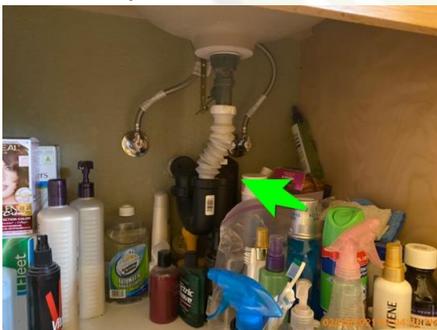
MM 146: Flex piping is installed at the sink drain line. While it is a popular product at Lowe's and Home Depot and it is considered poor practice to install flexible drain piping because it tends to clog easier and will usually drain slower. Alo

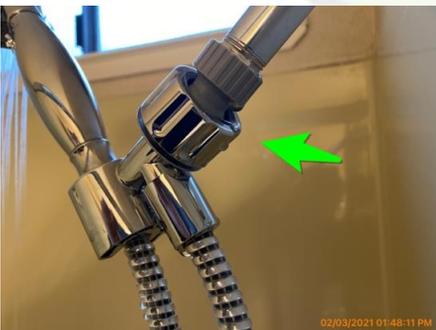
MM 158: Dripping observed at the showerhead. Left uncorrected this could cause moisture damage behind the shower / tub walls. Recommend repair and/or replace as needed.

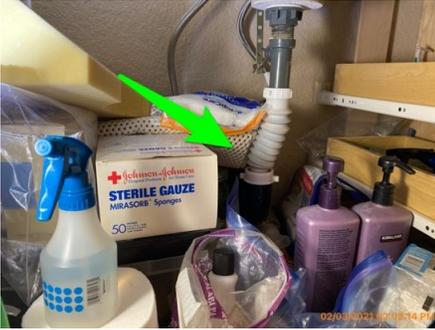
MM 166: Flex piping is installed at the sink drain line. While it is a popular product at Lowe's and Home Depot and it is considered poor practice to install flexible drain piping because it tends to clog easier and will usually drain slower. Alo

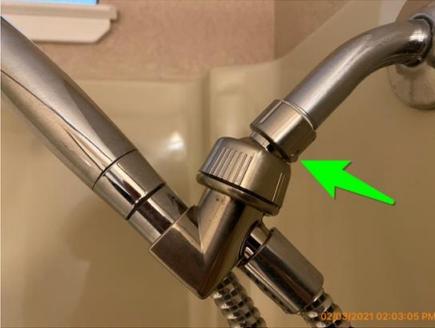
MM 169: Dripping observed at the showerhead. Left uncorrected this could cause moisture damage behind the shower / tub walls. Recommend repair and/or replace as needed.

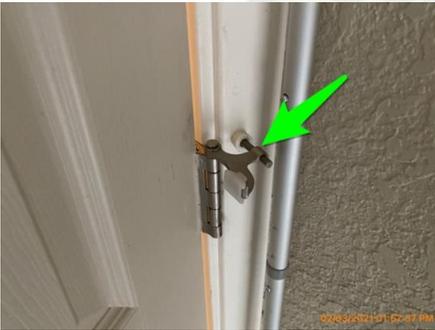
MM 184: Door stoppers are not preventing the door from contacting the wall in various locations and are in need of adjustment or replacing.

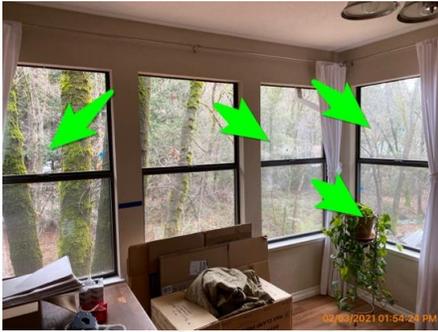
Dining Room

RR 201: Hardwater staining / scale noted to the exterior side of some of the windows, likely due to overspray of sprinklers or deferred maintenance over time. Make repairs as needed., There is moisture / condensation between window panes in the various locations including the dining room, living room and both upstairs front bedroom. This is a commonly seen defect in older double paned windows and generally considered a cosmetic repair. However, when there are multiple windows with condensation, it is more costly to repair. Have a qualified window contractor / glazer make further evaluation and repairs as needed. Blue tape has been placed on each window that the inspector was able to verify, visibly and that there is cosmetic damage.

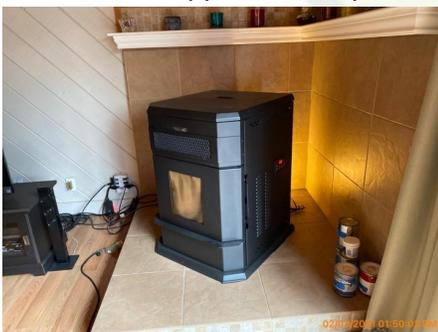
204: Stove located in the family room.

205: Pellet stove - General condition appears serviceable. Only use approved pellets in a pellet stove. The controls appeared to operate properly at the time of the inspection.

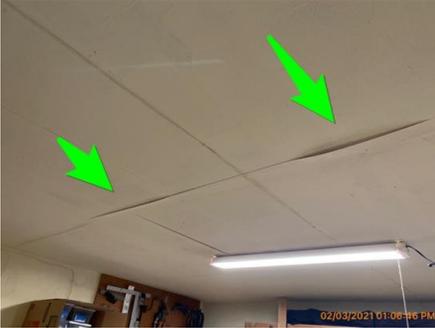
MM 223: Some of the drywall tape that seals the seams and completes the firewall has come loose and needs to be replaced.

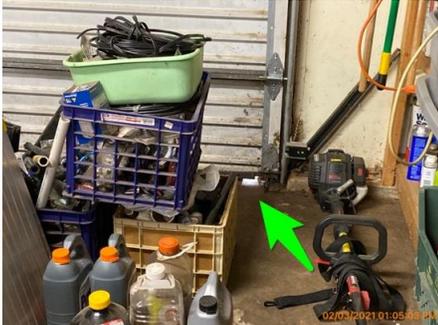
MM 230: There is a small gap at the left side and right side of the door when it is closed. This is a potential point of entry for water and pests / animals. Recommend adjustment of weather stripping as needed.

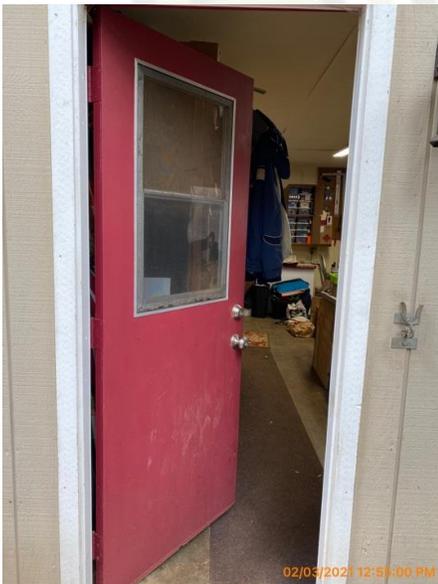
EXTERIOR DOORS

232: Appears serviceable. Hardware operational. The window in the door appears serviceable. The window is vertically hung and can open.

RR 233: Deterioration noted to door and jamb. A qualified trim carpenter should be called to make repairs as needed. Also refer to pest inspection report for repair recommendations.
